FOCUS ON FLAMINGOS AND POWER LINES

Power line survey: Trekkopje – Wlotzka 132 kV (TRE/WLO 1-186) and the start of the Trekkopje – Henties Bay 66 kV bypass (W1 – W16)

Survey details

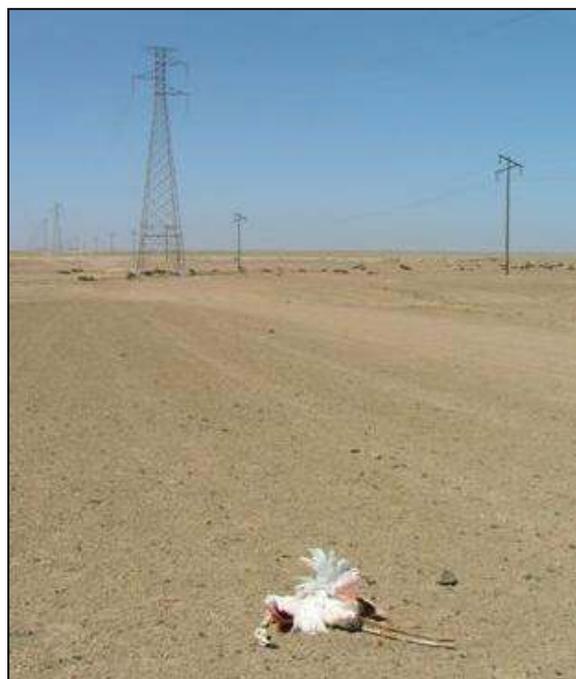
Flamingo mortality on a power line between Swakopmund and Walvis Bay in 2007 (photo Gloudi de Beer)

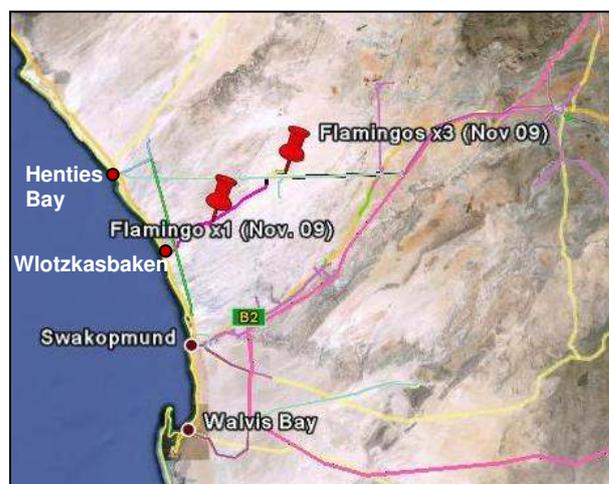
Google image showing sites of flamingo collisions (red markers) on the new 132 kV Trekkopje-Wlotzka line north-east of Swakopmund (left), and 66 kV Trekkopje Bypass (right) (based on a Google map generated by Alice Jarvis [EIS]).

(1) On the 132kV – the flamingo was spotted between Towers [TRE / WLO 136] and [TRE / WLO 139], which

is located between Lichen and Dolorite Sub-station. (2) On the 66kV – the flamingos were reported between the first angled strain tower (W 12) and the intermediate just after the river crossing (W 16).

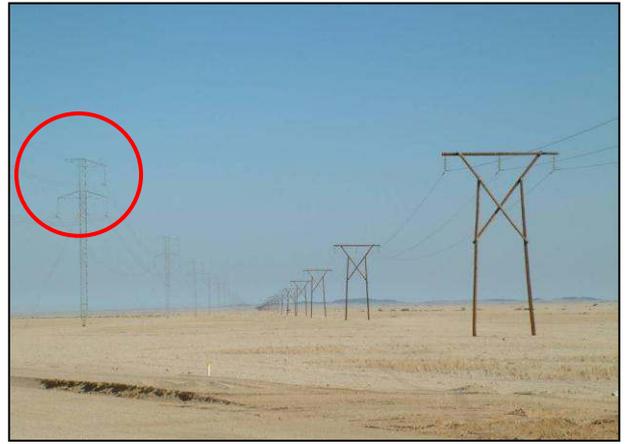
The 66 kV Trekkopje Bypass line (right, with wooden five-pole structures) runs parallel to the larger 220 kV line (left); it is possible that the three flamingos collided with the less visible earth/optic fibre ground wires (red circle above and red arrows below) on the latter structure (photos Ann Scott)

We investigated from Tower W1 (S22.13606 E14.89558) to W16 (S22.11880 E14.87559); about 2.9 km (towers are on average 180m apart). The incident took place between Tower W12 and W16; but possibly on the high, less visible optic fibre ground wire (OPGW) of the adjacent 220 kV line.

1. **Mitigation:** Investigate mitigation in problem areas already identified in this report. The Mace Bird Lite and/or blinking solar powered aviation lights attached to the optic fibre ground wires could be tested on an experimental basis. Investigate markers that could possibly provide an (ultra-sonic) auditory signal.

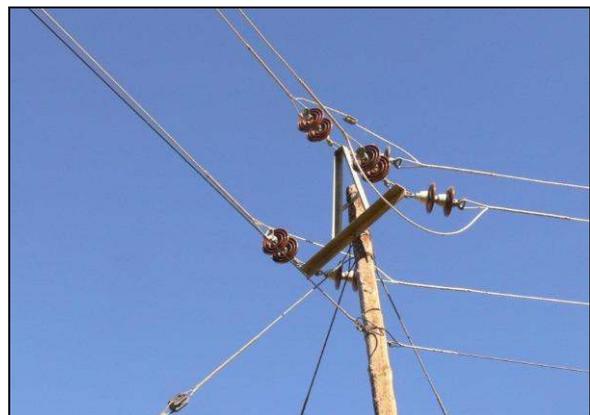
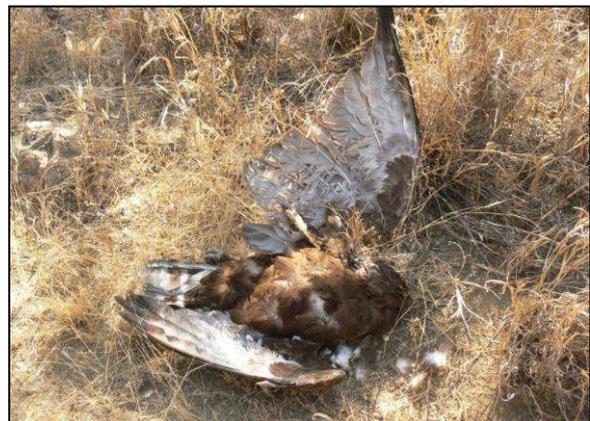
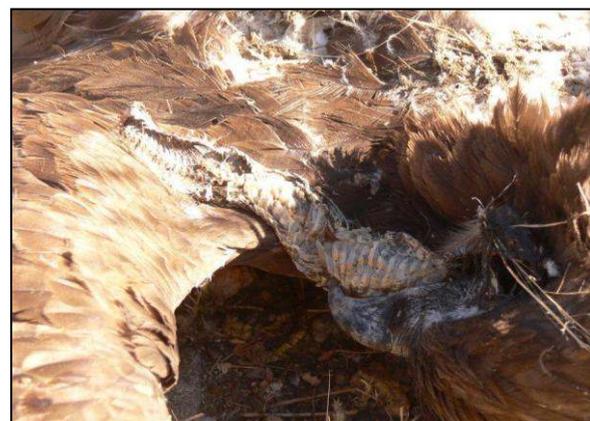
On 8/8/10, Neil and Gudrun found the remains of a Brown Snake-eagle at Gammams Sewage Works, in the north-western part of Windhoek (22 32.095S 17 01.623E; Tower 935). The remains of a large snake were visible in the birds' talons. They assume that the eagle had killed the snake and perched on the pole to eat it and that the snake may have touched a conductor, electrocuting the bird. Both carcasses were about a week old.

Top: The A-frame pole structure is normally considered 'safe' for perching raptors.
 Centre: The body of the snake may have touched a conductor, electrocuting the bird.
 Bottom: The remains of the snake were still visible in the bird's talons (photos Neil Thomson)

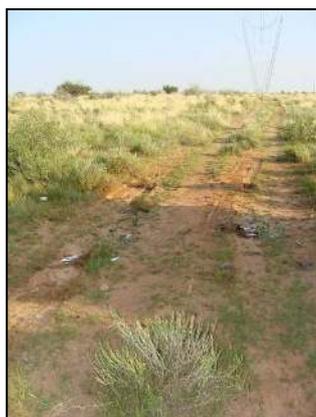
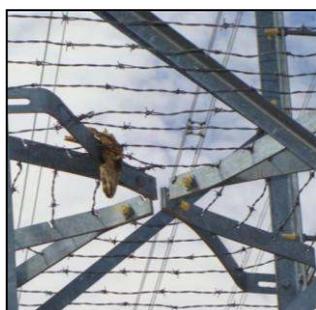
- Bustard x1 (Kori?) – Tower 622
- Bones (vulture?) – Tower 622
- Water bird (heron?) – Tower 463
- Nest of Black-chested Snake-eagle (Tower 622)
- Rock monitor – Tower 461 (probably prey remains)

Top (left) Remains of a bustard.
 Top (right) Remains of vulture.
 Bottom (left) Remains of rock monitor.
 Centre and bottom (right) Black-chested Snake-eagle and nest
 (Photos AC van Zyl)
